Washington State
School Seismic Safety Assessments Project

MARYSVILLE-PILCHUCK HIGH SCHOOL LIBRARY (BUILDING J) Marysville School District 25

SEISMIC UPGRADES CONCEPT DESIGN REPORT

June 2021

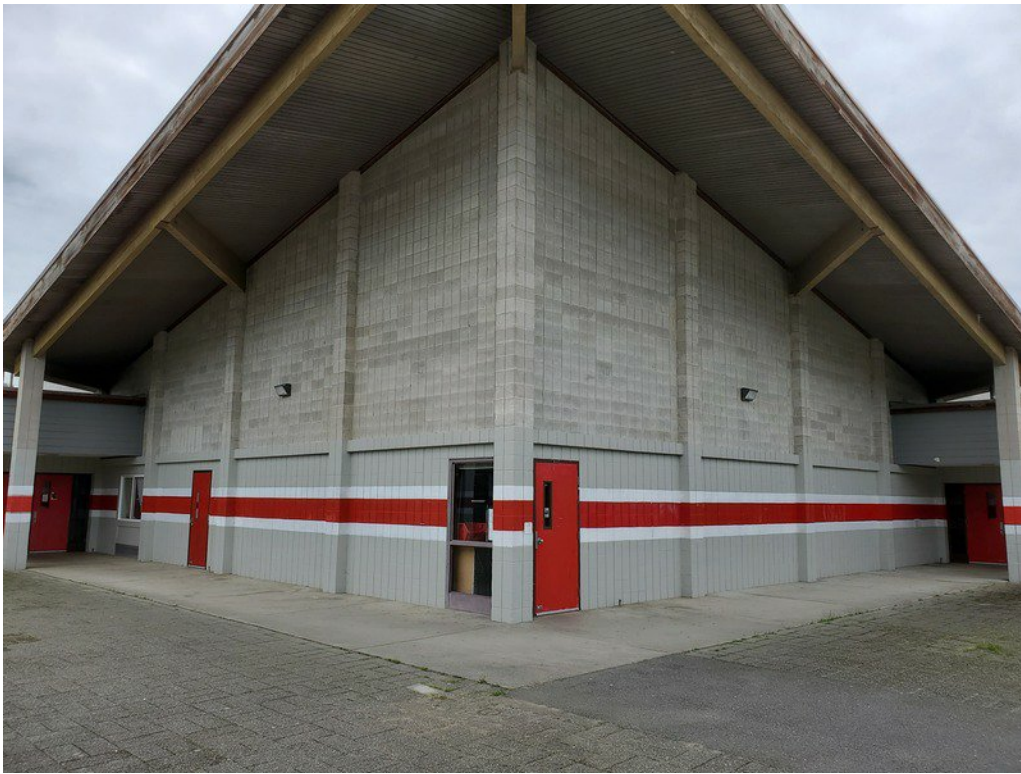
Figure 1-1. Building J, Southwest Corner

Structural System	Description
Structural Roof	No visible deterioration or damage was observed.
Structural Floor(s)	No visible deterioration or damage was observed.
Foundations	No visible deterioration or damage was observed.
Gravity System	No visible deterioration or damage was observed.
Lateral System	No visible deterioration or damage was observed.

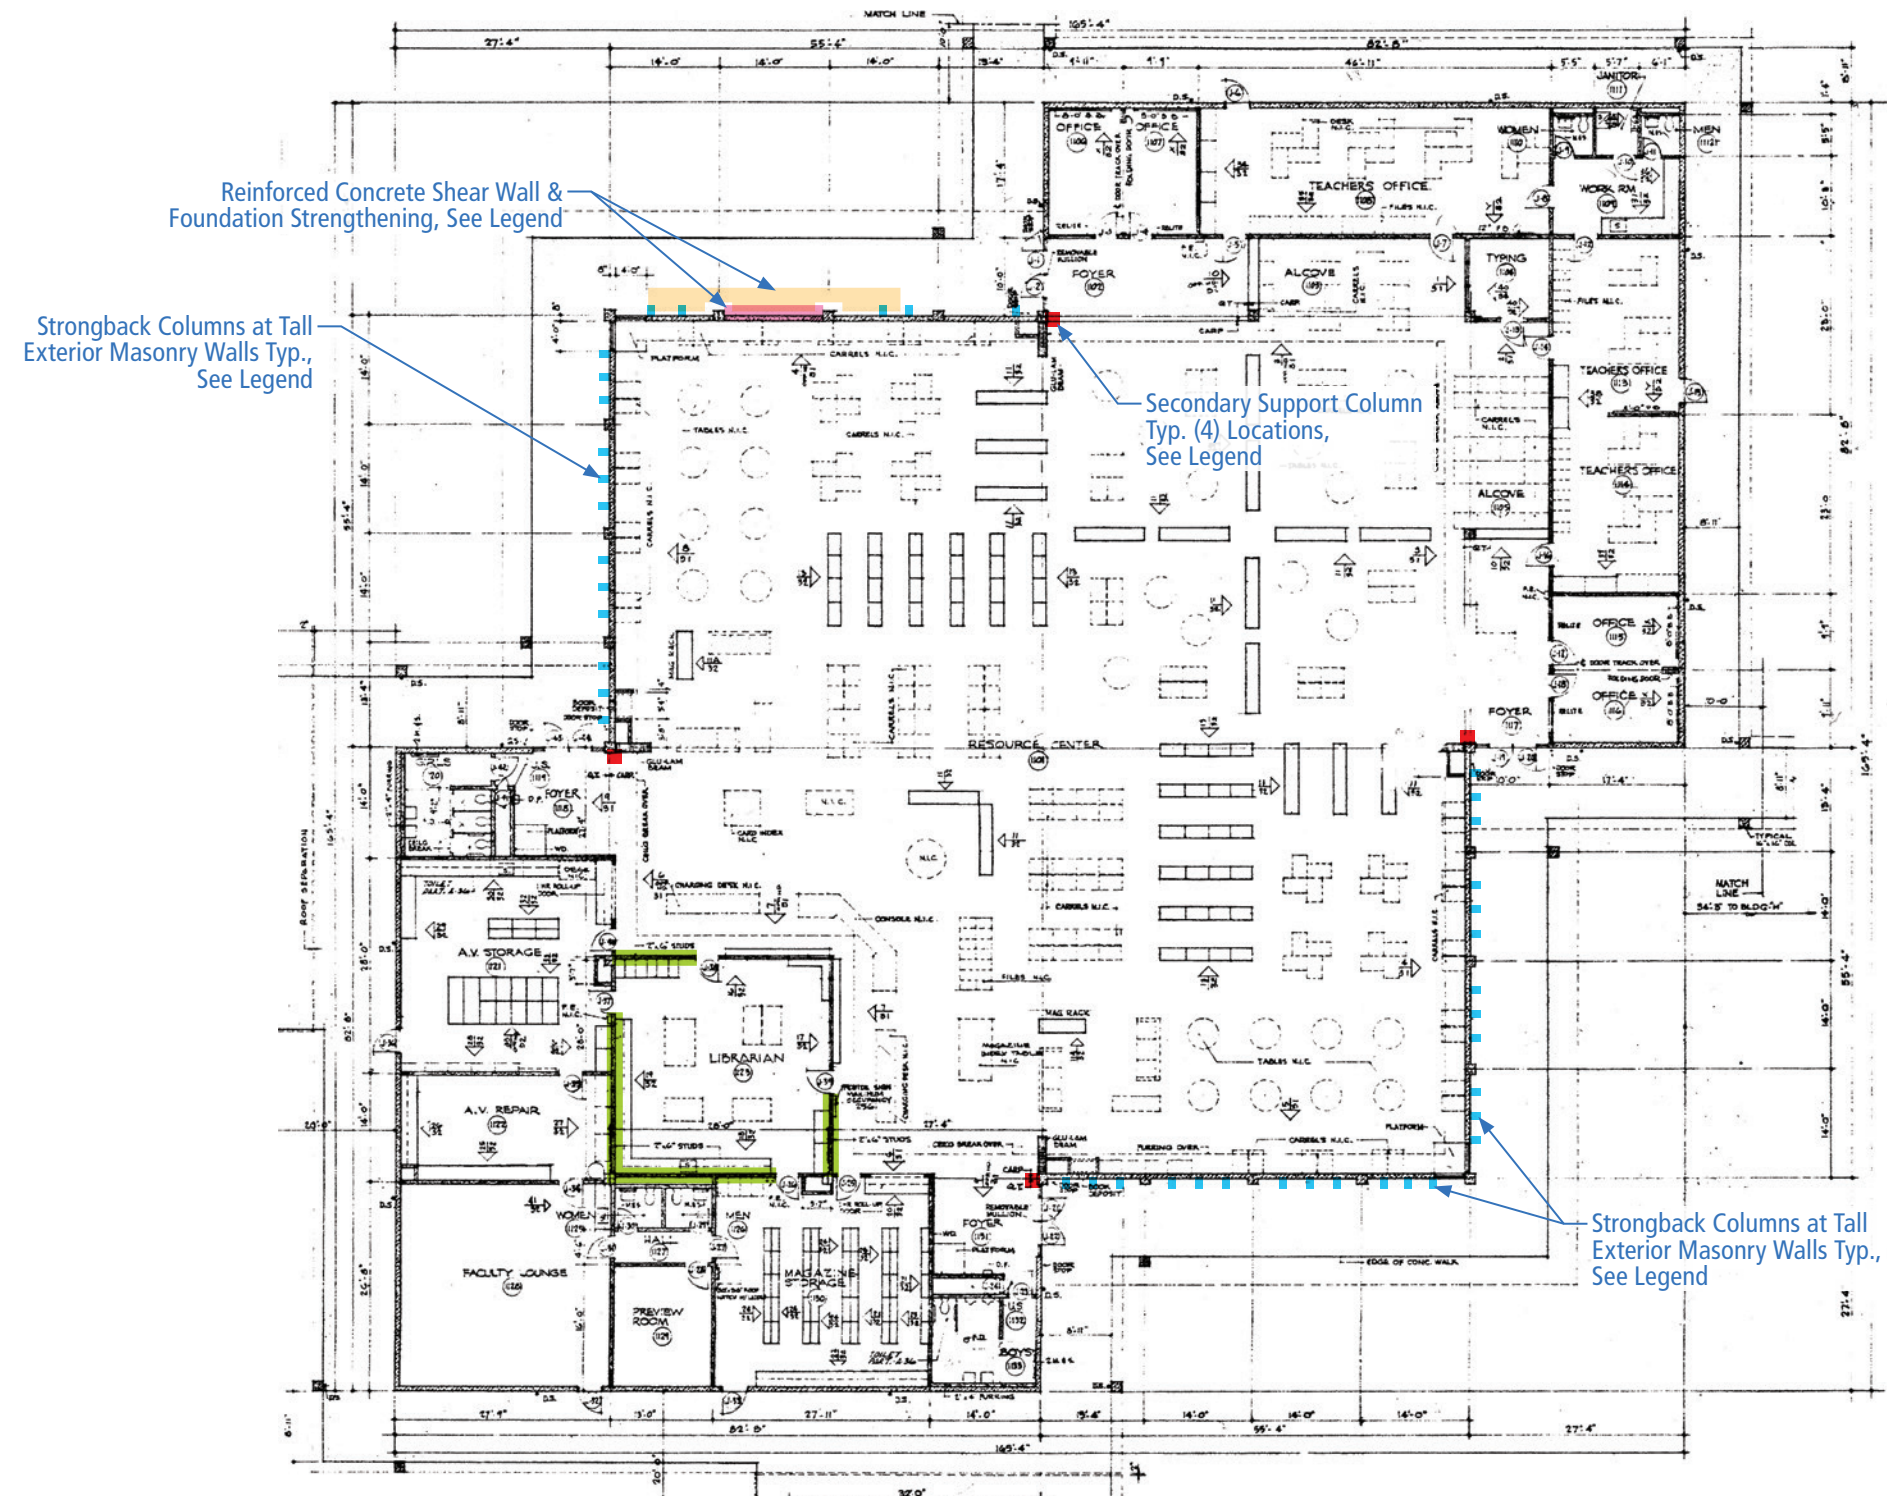
Deficiency	Description
Adjacent Buildings	The covered walkway attached to this structure is immediately adjacent to the covered walkway attached to the adjacent structure.
Reinforcing Steel	The minimum of 0.0007 in either of the two directions is not satisfied. Vertical reinforcing steel consists of #4 at 48 inches on center, which produces a reinforcing ratio of 0.00055.
Foundation Dowels	The south, west, and north masonry cavity walls of the 1962 library were not detailed to have vertical dowels connecting the 8-inch masonry backup wall to the foundation.
Cross Ties	Continuous cross-ties are not present in longitudinal (east-west) direction.
Wall Anchorage	Exterior and interior masonry bearing walls were not detailed to have out-of-plane anchorage or bracing to the roof diaphragm.
Wood Ledgers	The lower roof that frames in to the east face of the masonry wall, between the library and science lab, is supported by a 3x ledger without wall anchor ties directly attached to the diaphragm.

- 8-Inch Reinforced Shotcrete Wall, See Detail F on Figure 3
- Foundation Strengthening Under Shotcrete Shear Wall, See Detail F on Figure 3
- HSS 7x3x3/8 At 40" OC Max Strongbacks With Anchor Clips To Outside Face Of Existing CMU At 4' OC Full Height, See Detail C on Figure 3
- HSS 5x5x1/4 Column For Secondary Support For Existing GL Beam Above
- Sheathe & Nail Existing Stud Wall As Shear Wall With 1/2" Plywood, Blocking Between Studs, & Holdowns At Each End
